FINAL REPORT NUMBER 201U-MGA-04-06

SAFETY COMPLIANCE TESTING FOR FMVSS 201U
Occupant Protection In Interior Impact
Upper Interior Head Impact Protection

LAND ROVER IN THE UK
2004 LAND ROVER FREELANDER SE MPV
NHTSA No. C40602

MGA RESEARCH CORPORATION
446 Executive Drive
Troy, Michigan 48083

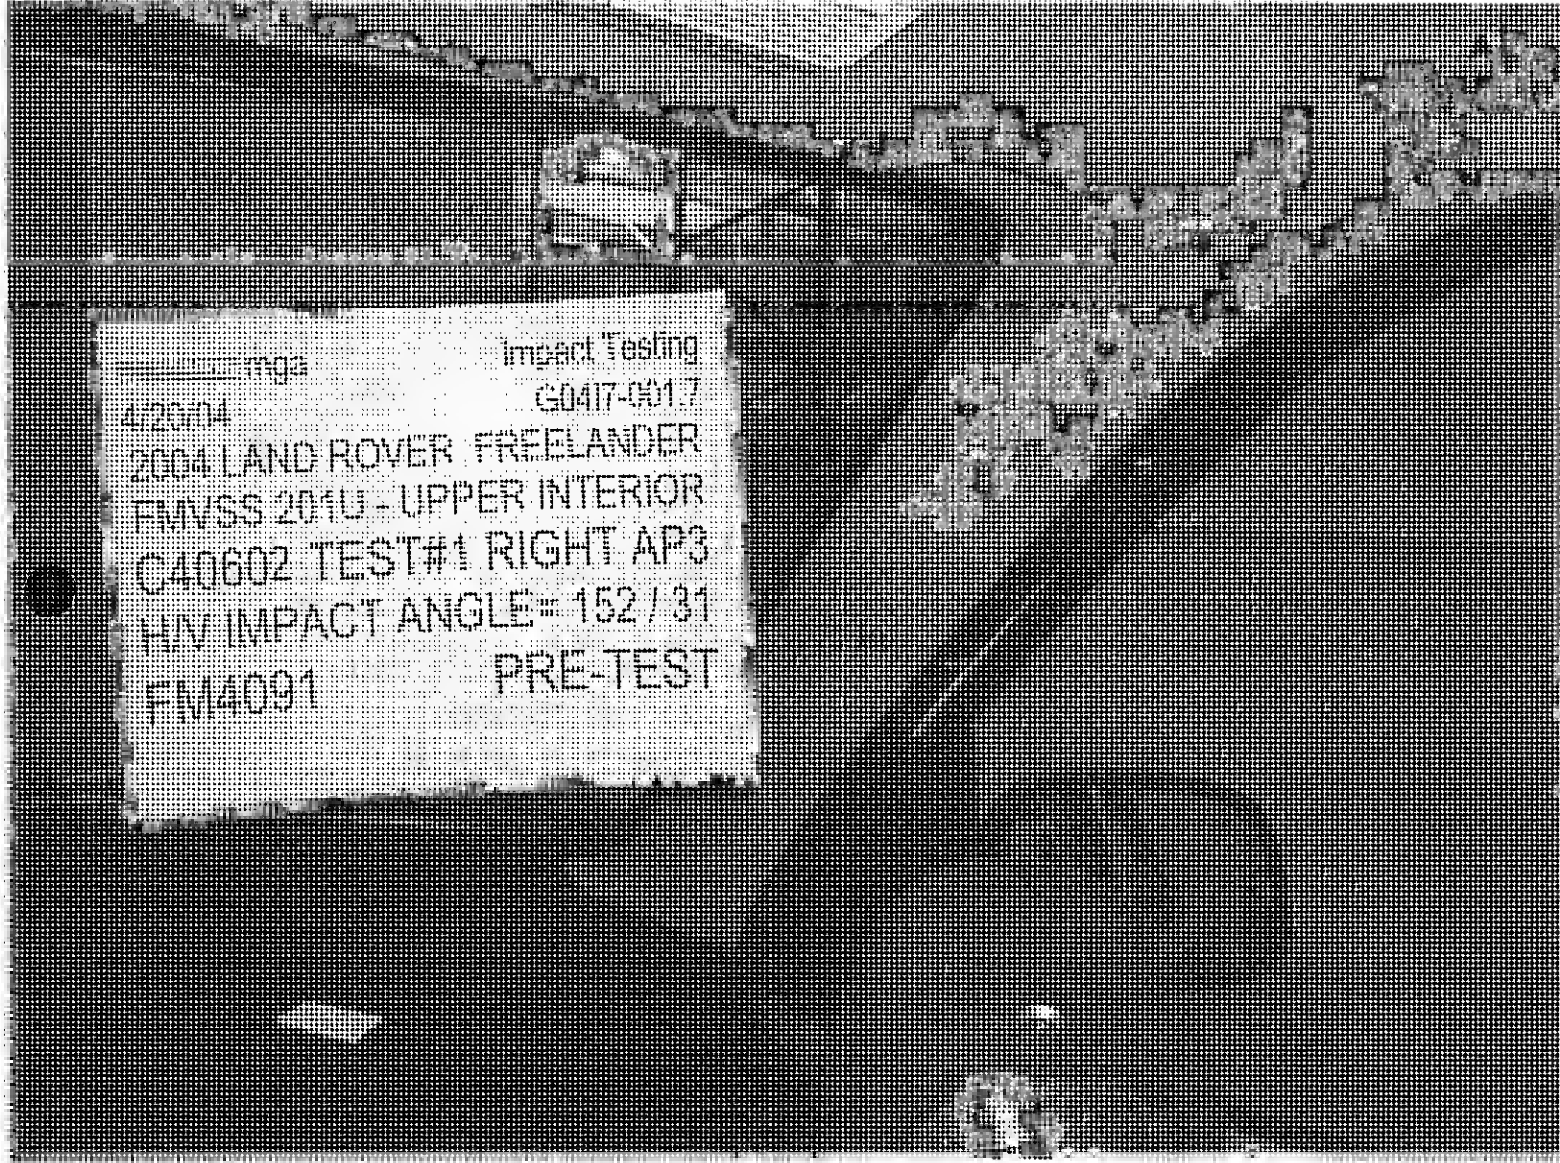
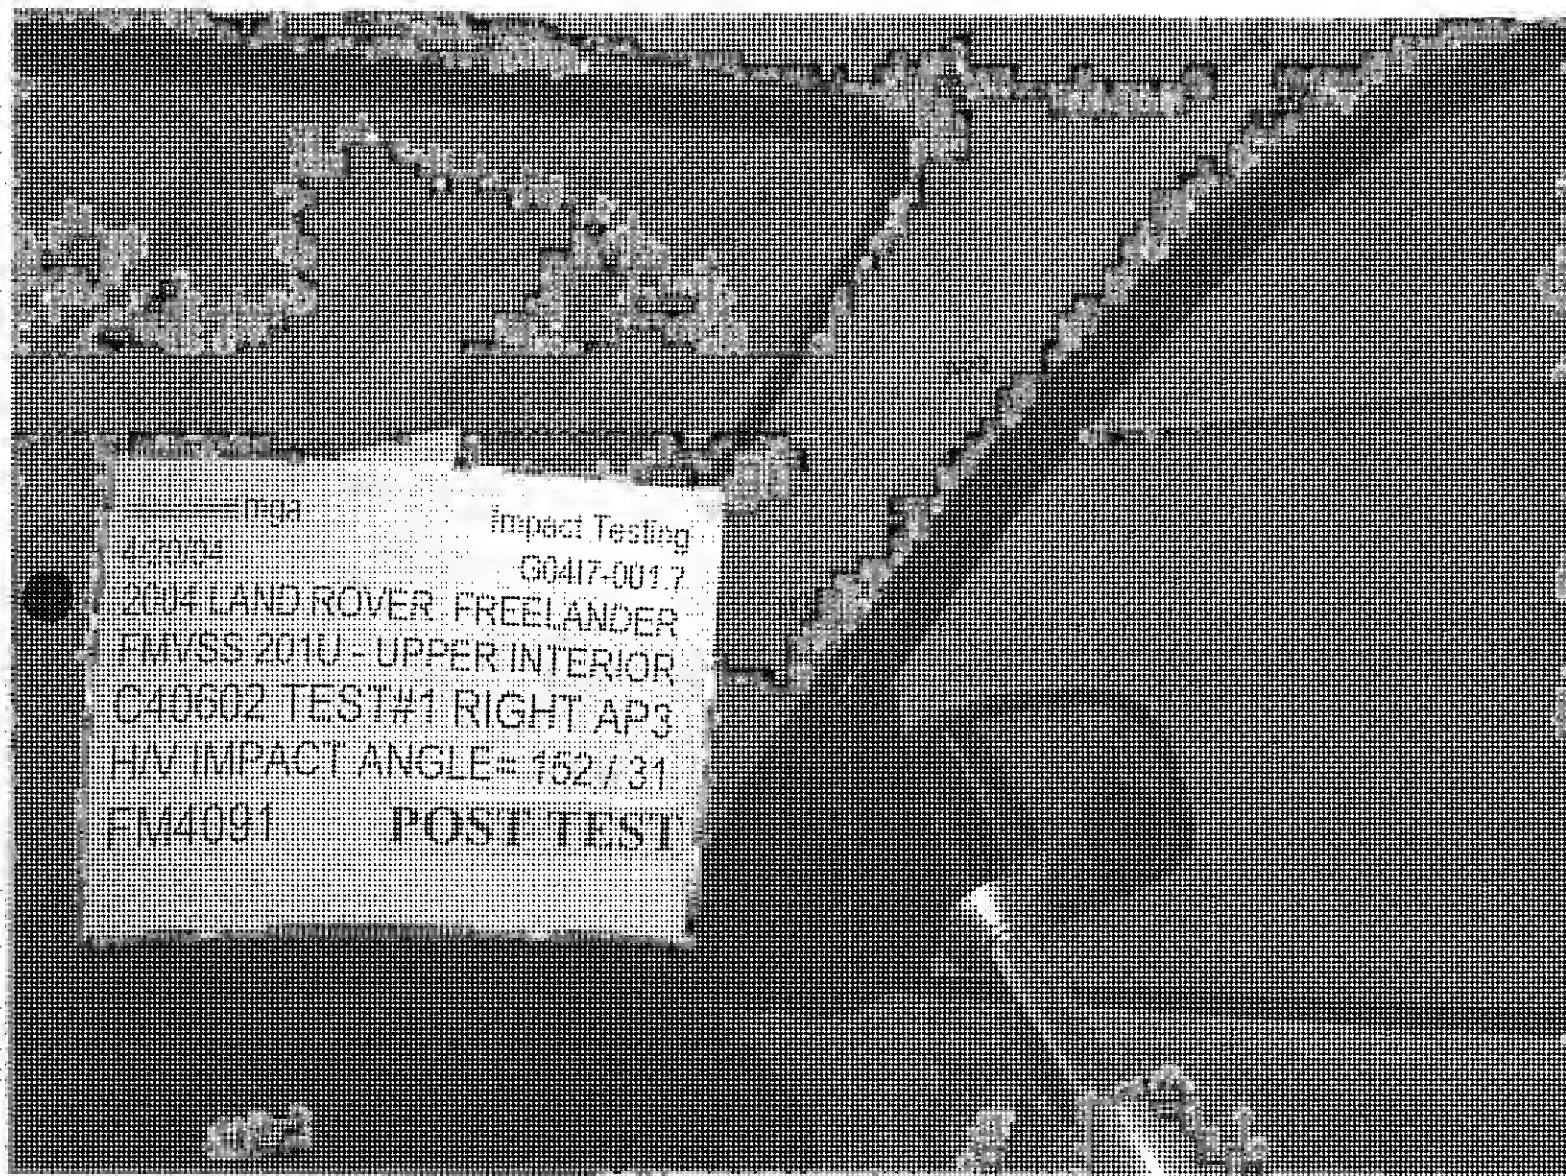
4/20/04 Impact Testing
G0417-001.7
2004 LAND ROVER FREELANDER
FMVSS 201U - UPPER INTERIOR
C40602 TEST#1 RIGHT AP3
HV IMPACT ANGLE = 152 / 31
FM4091 PRE-TEST

The 2004 Land Rover Freelander SE MPV tested does not appear to comply with the performance criteria for FMVSS 201U. The HIC(d) measured using the Part 572L (Free Motion Headform) was above 1000 for Target AP3 (Right).

AP3 Right: No visible damage. Apparent test failure.

NO VISIBLE DAMAGE

APPROXIMATE TEST FAILURE

APPARENT TEST FAILURE DESCRIPTION: A-PILLAR TARGET #3 (AP3), LOCATED ON THE LOWER PORTION OF THE A-PILLAR. THE HORIZONTAL AND VERTICAL ANGLES WERE 152 AND 31 DEGREES RESPECTIVELY. THE CALCULATED HEAD IMPACT CRITERIA(d) WAS 1062, AT AN IMPACT VELOCITY OF 23.9 KPH.

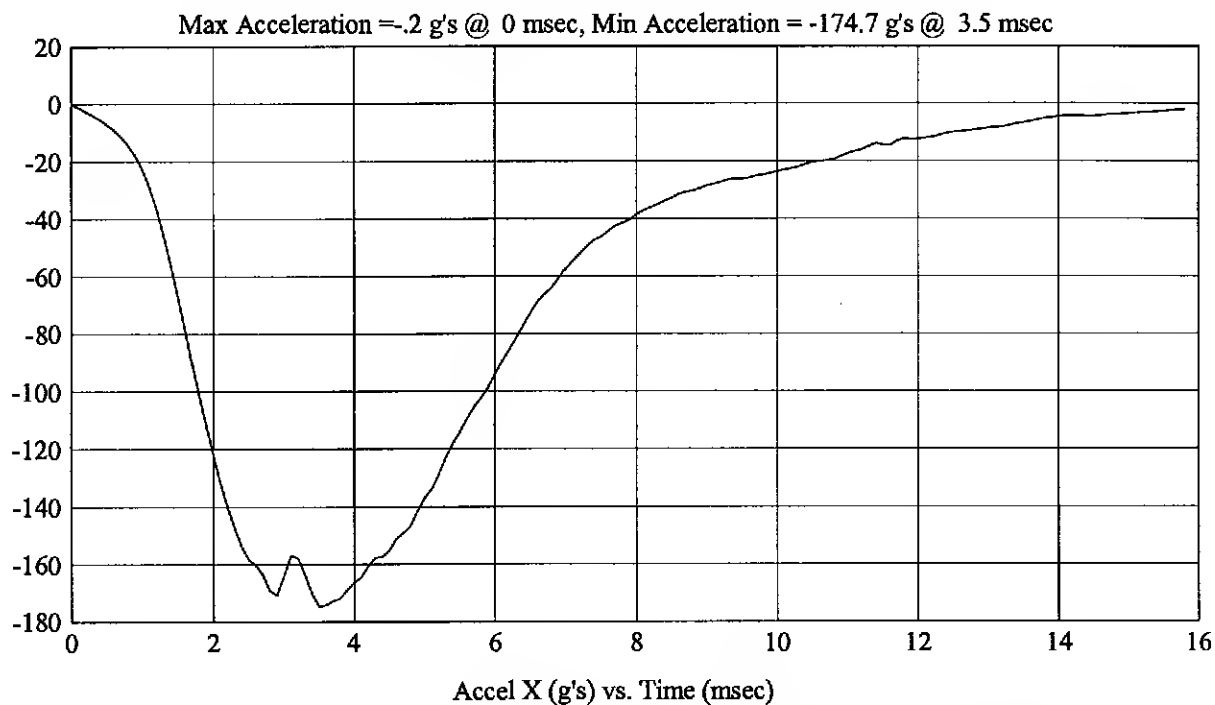
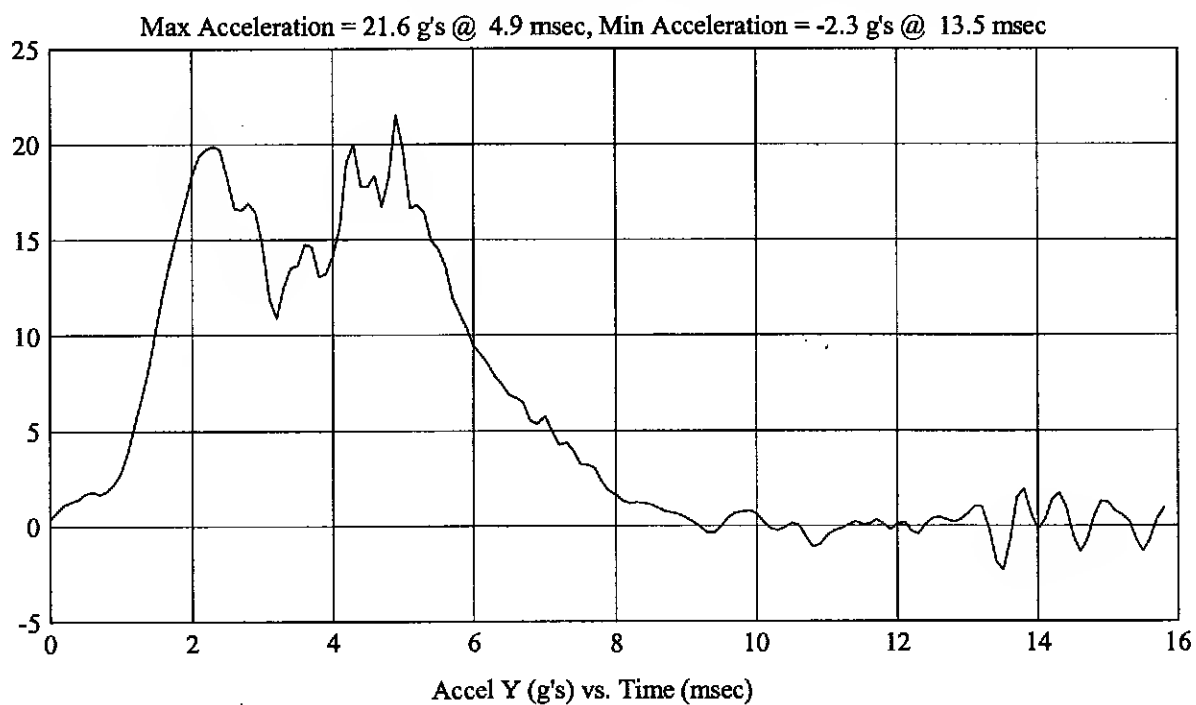
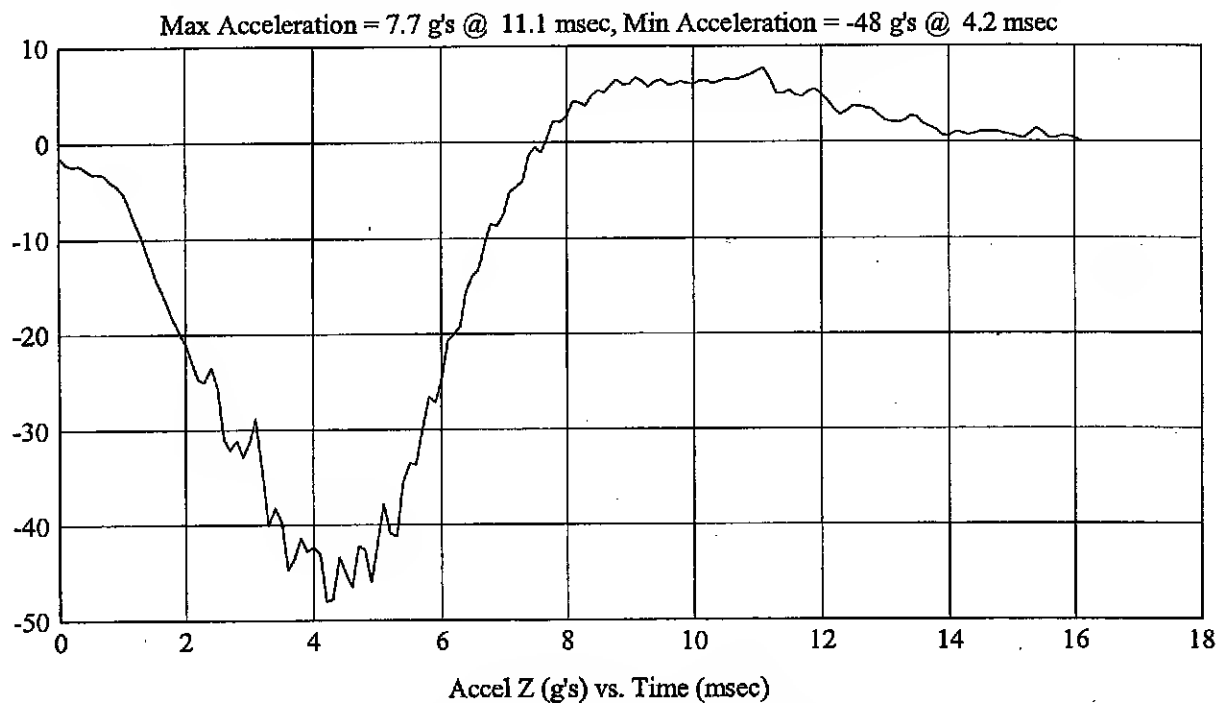
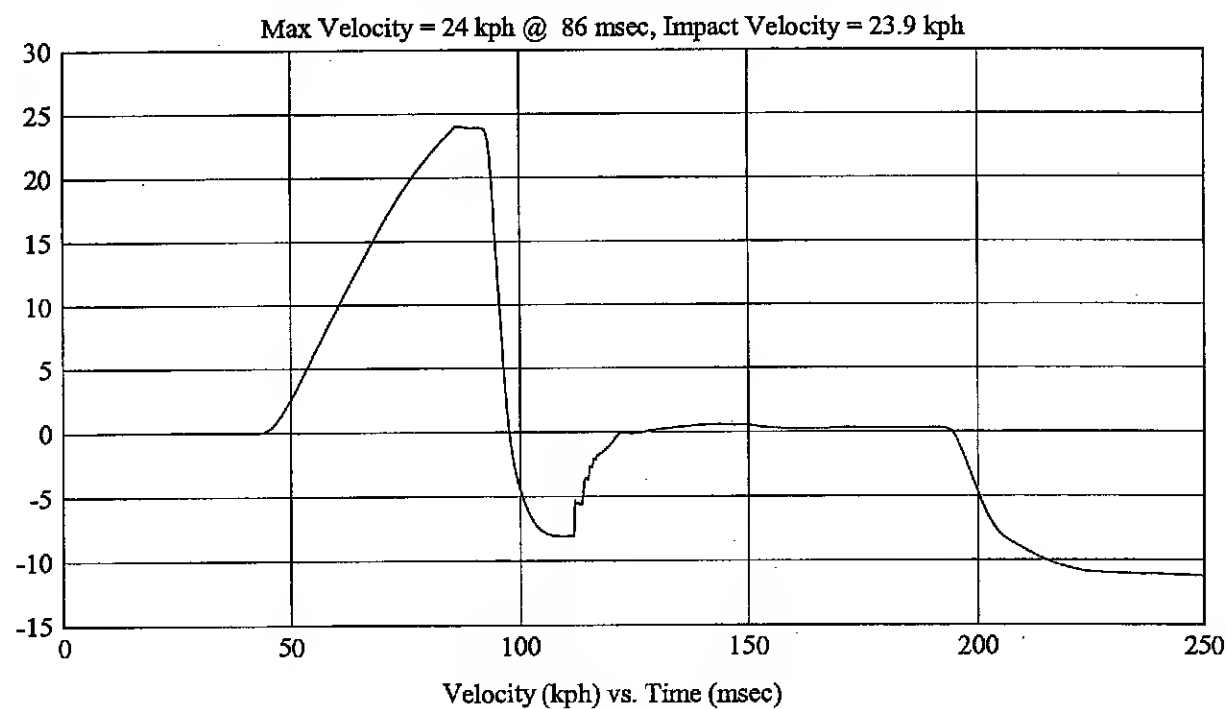
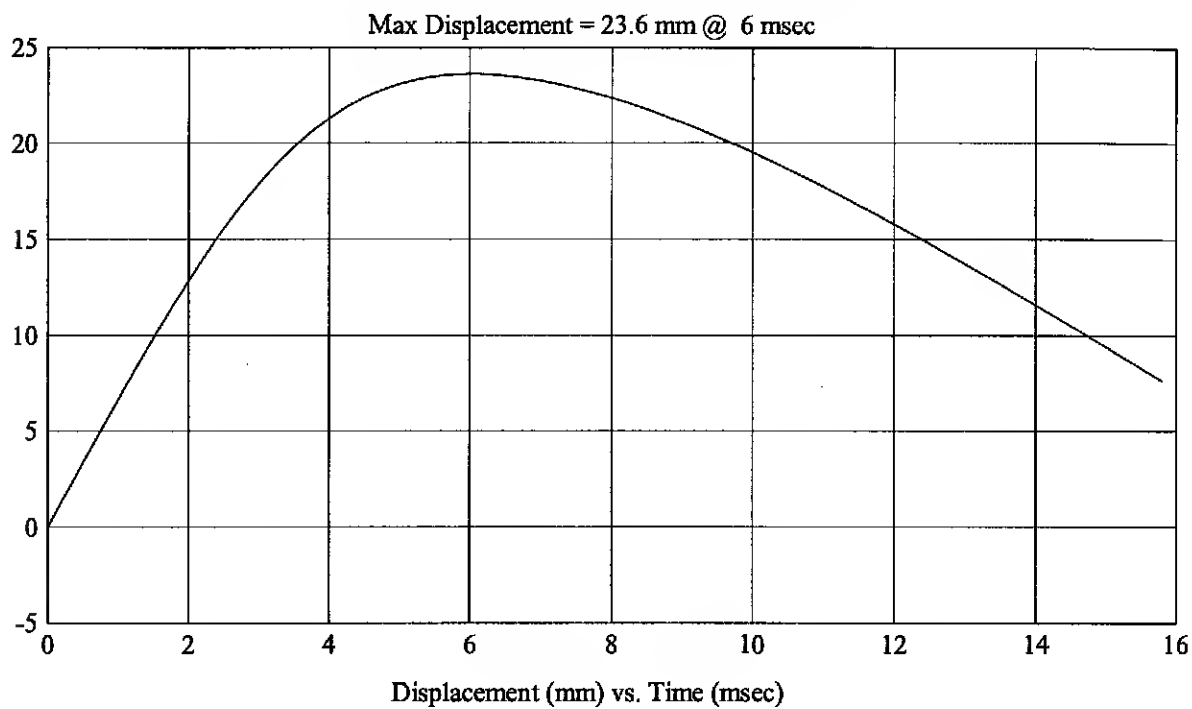
Model Year: 2004
Target: AP3
Vehicle Side: Right
Horz/Vert Angle: 152/31

HIC(d) = 1062, HIC = 1187, Delta T = 4.5 msec

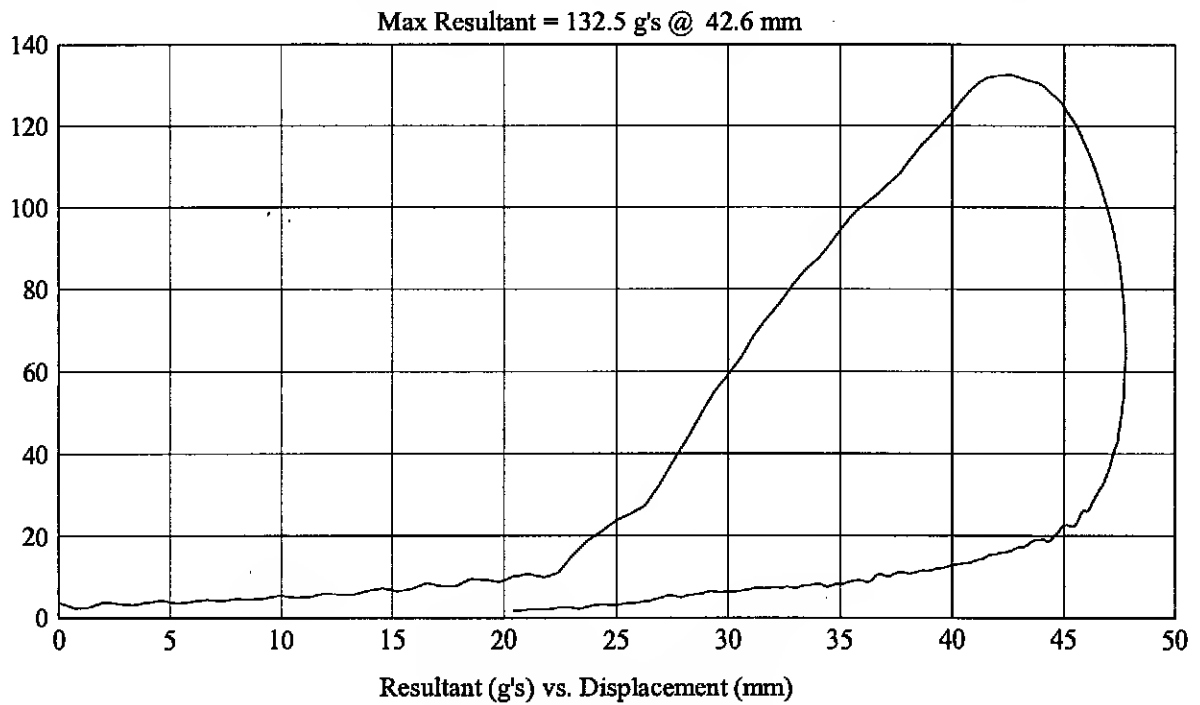
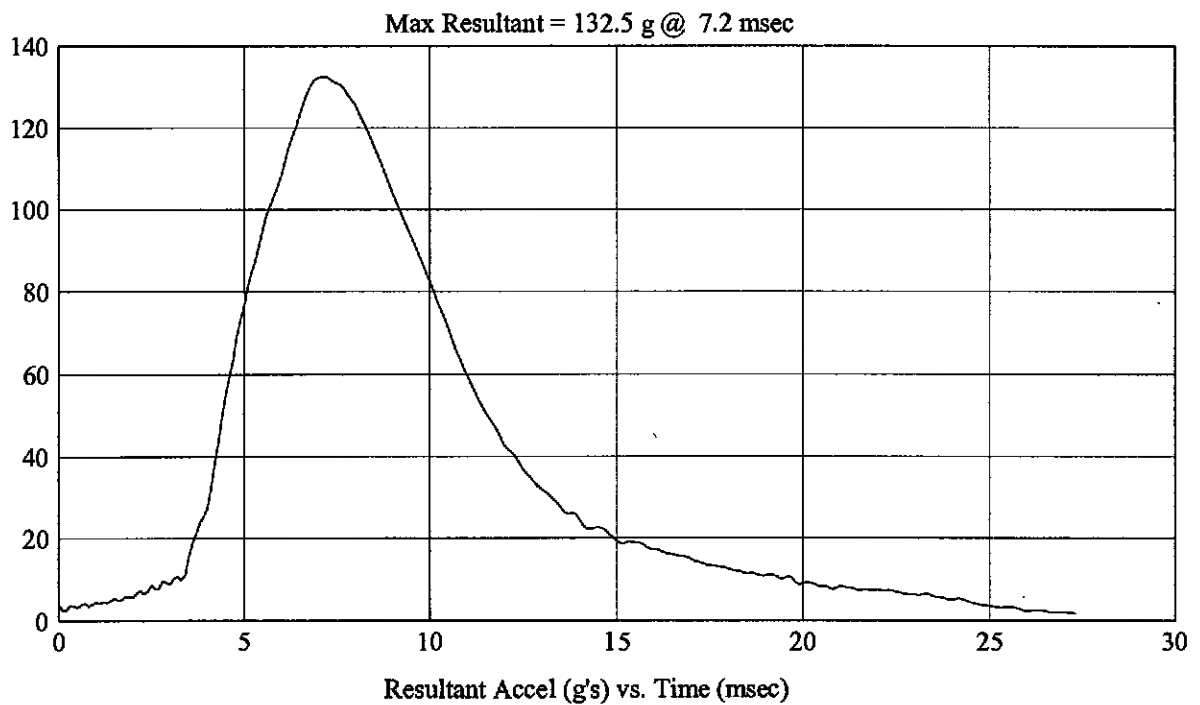
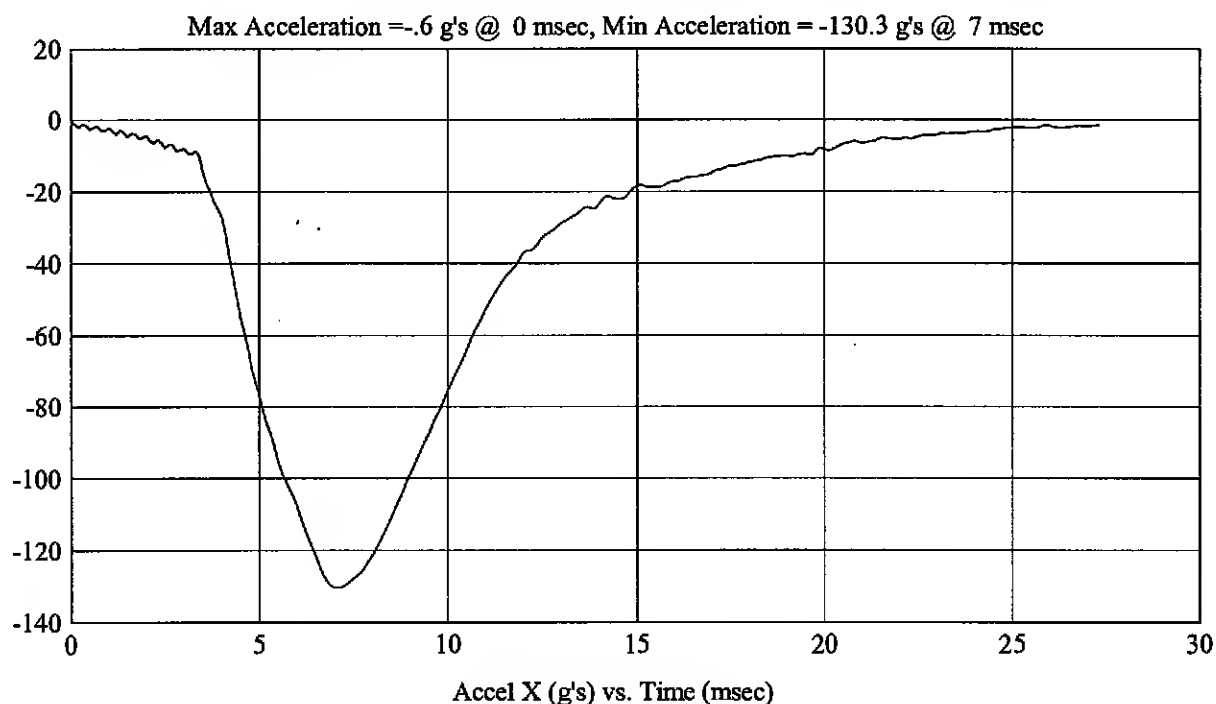
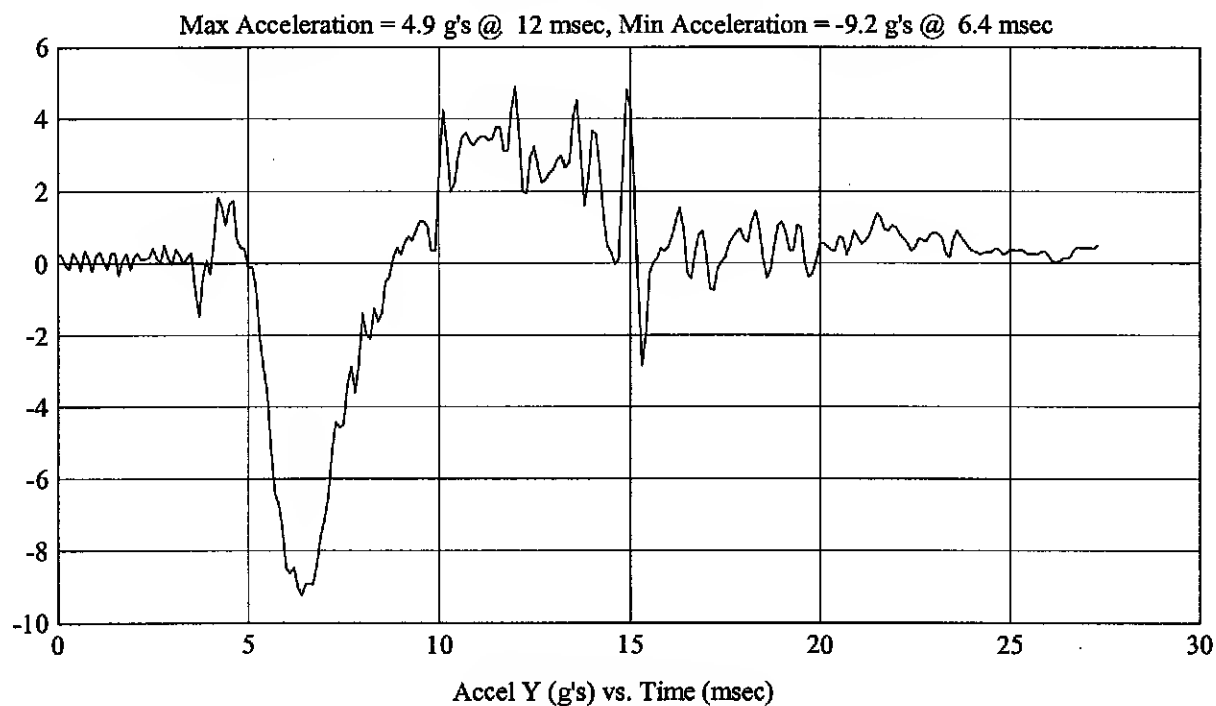
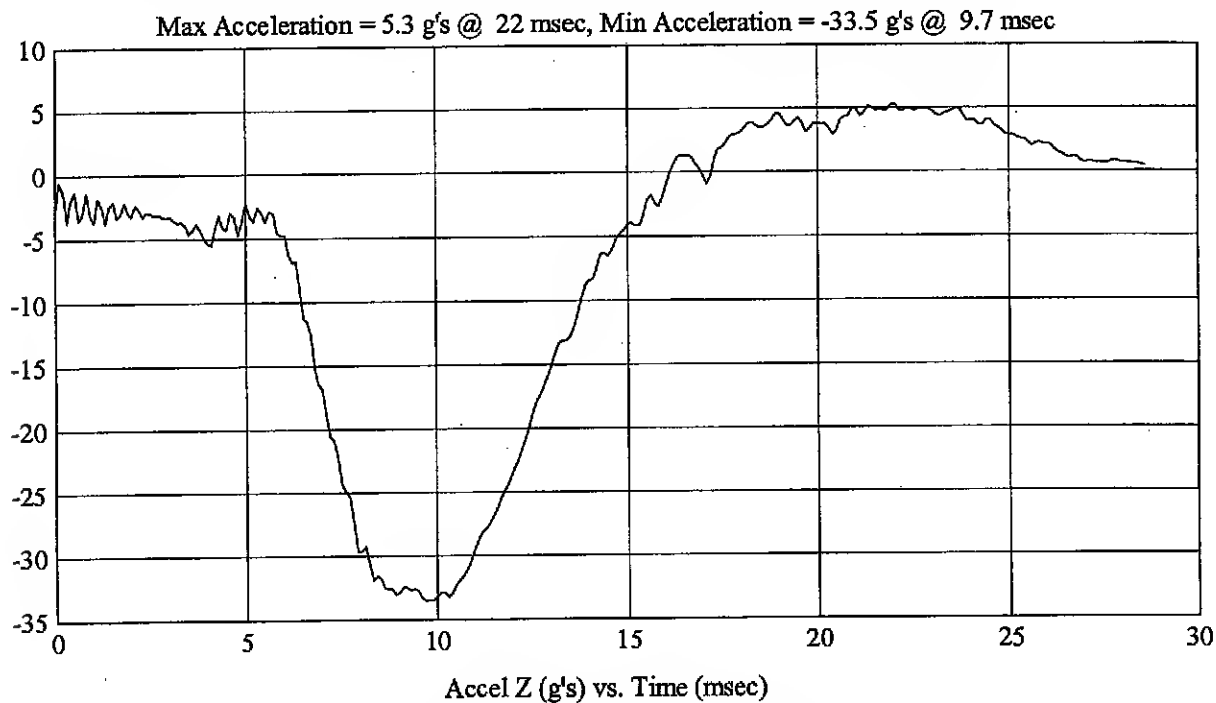
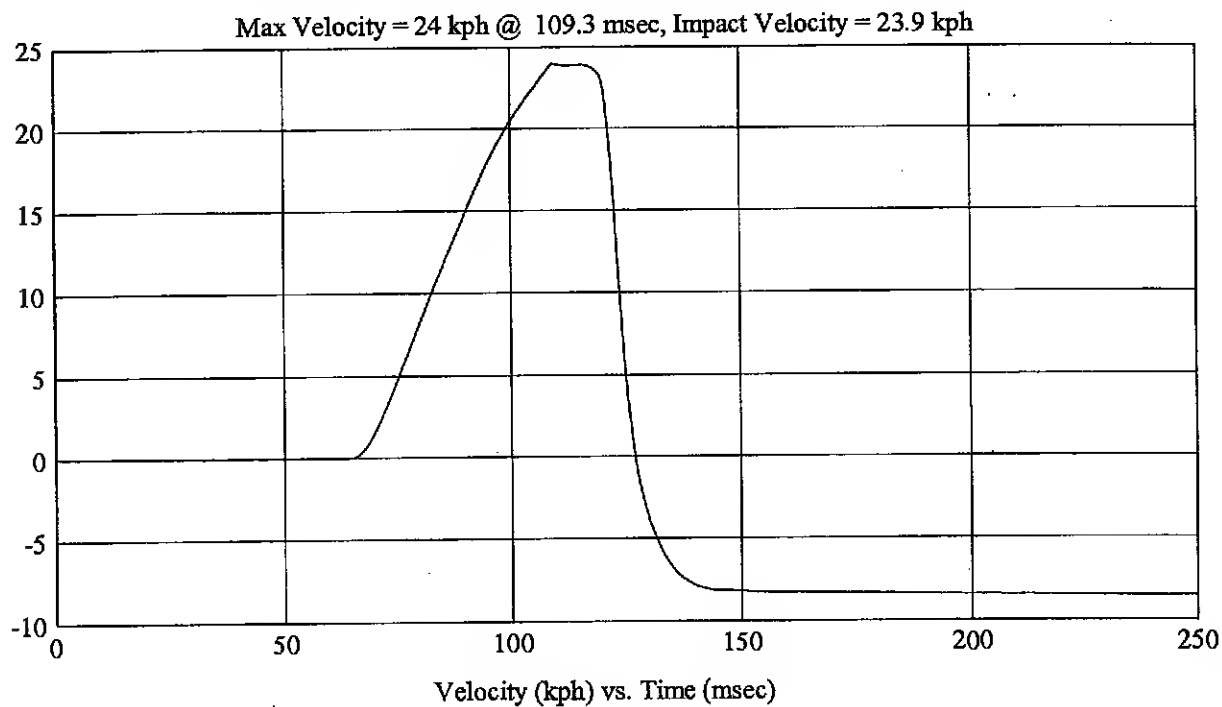
Model Year: 2004
Target: BP1
Vehicle Side: Left
Horz/Vert Angle: 270/10

BP1 Left: B-Pillar trim was compressed into the side rail.

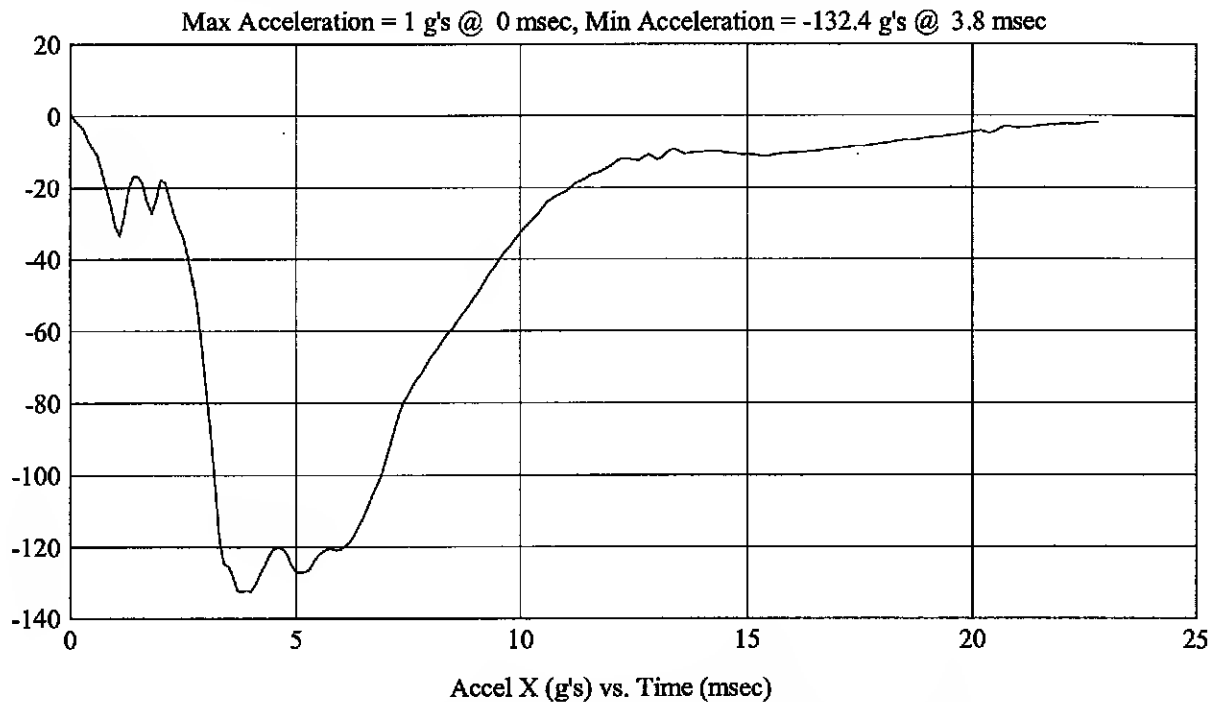
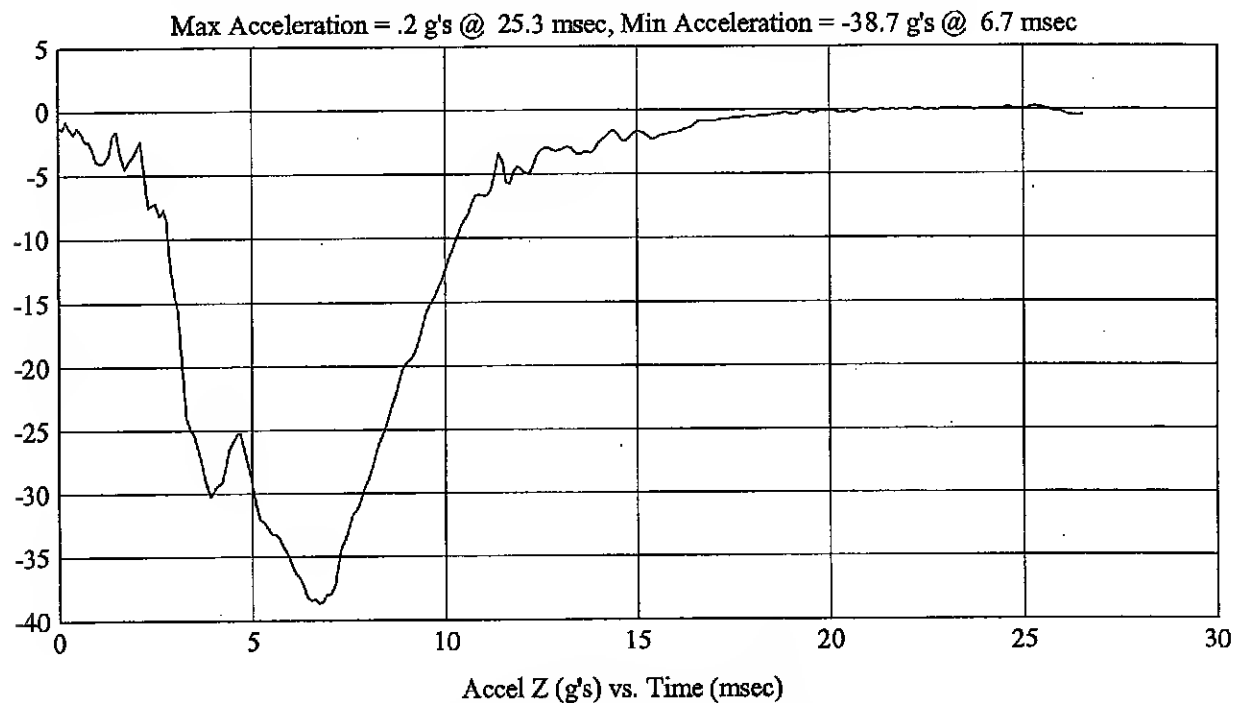
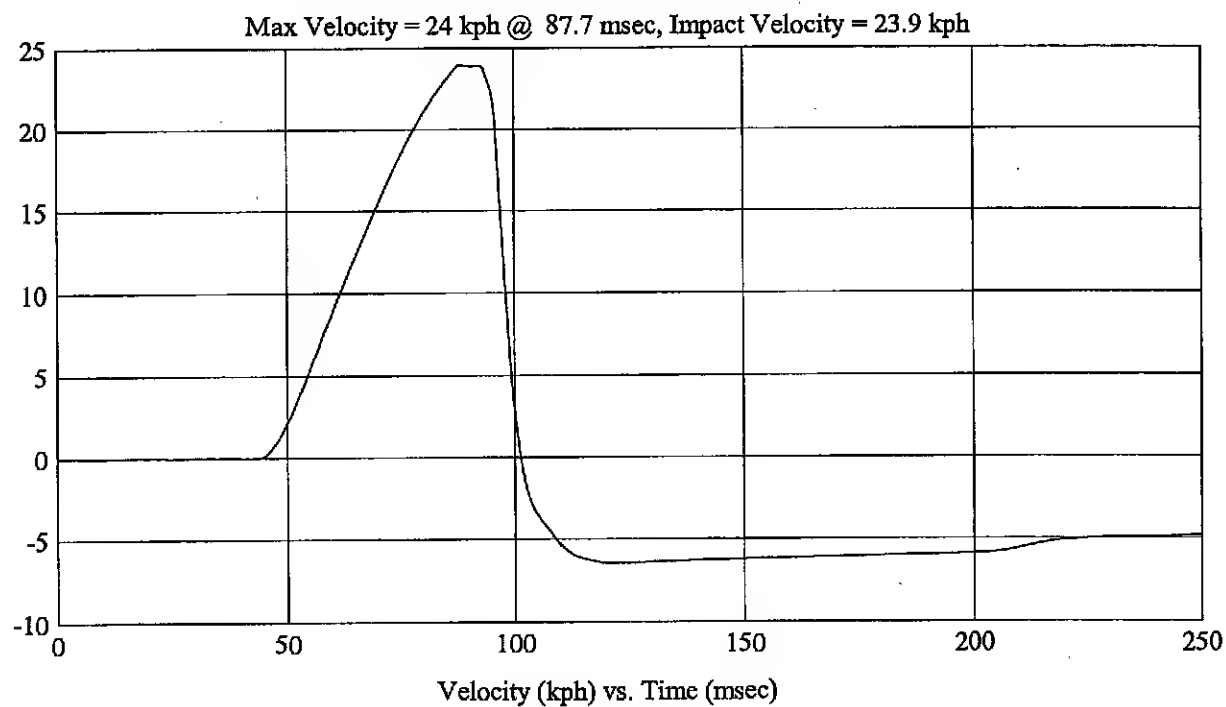
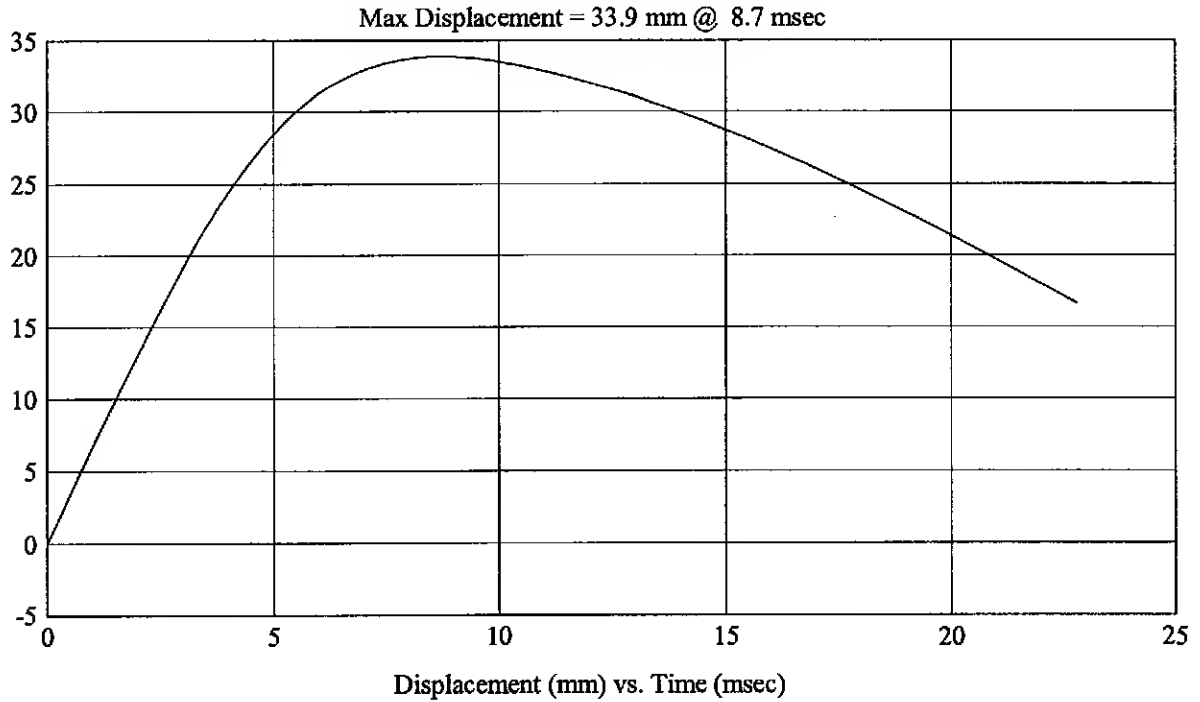
Model Year: 2004
Target: BP2
Vehicle Side: Right
Horz/Vert Angle: 90/3

BP2 Right: The seat belt anchorage cover was cracked during impact.

SEAT BELT ANCHORAGE COVER WAS CRACKED DURING IMPACT

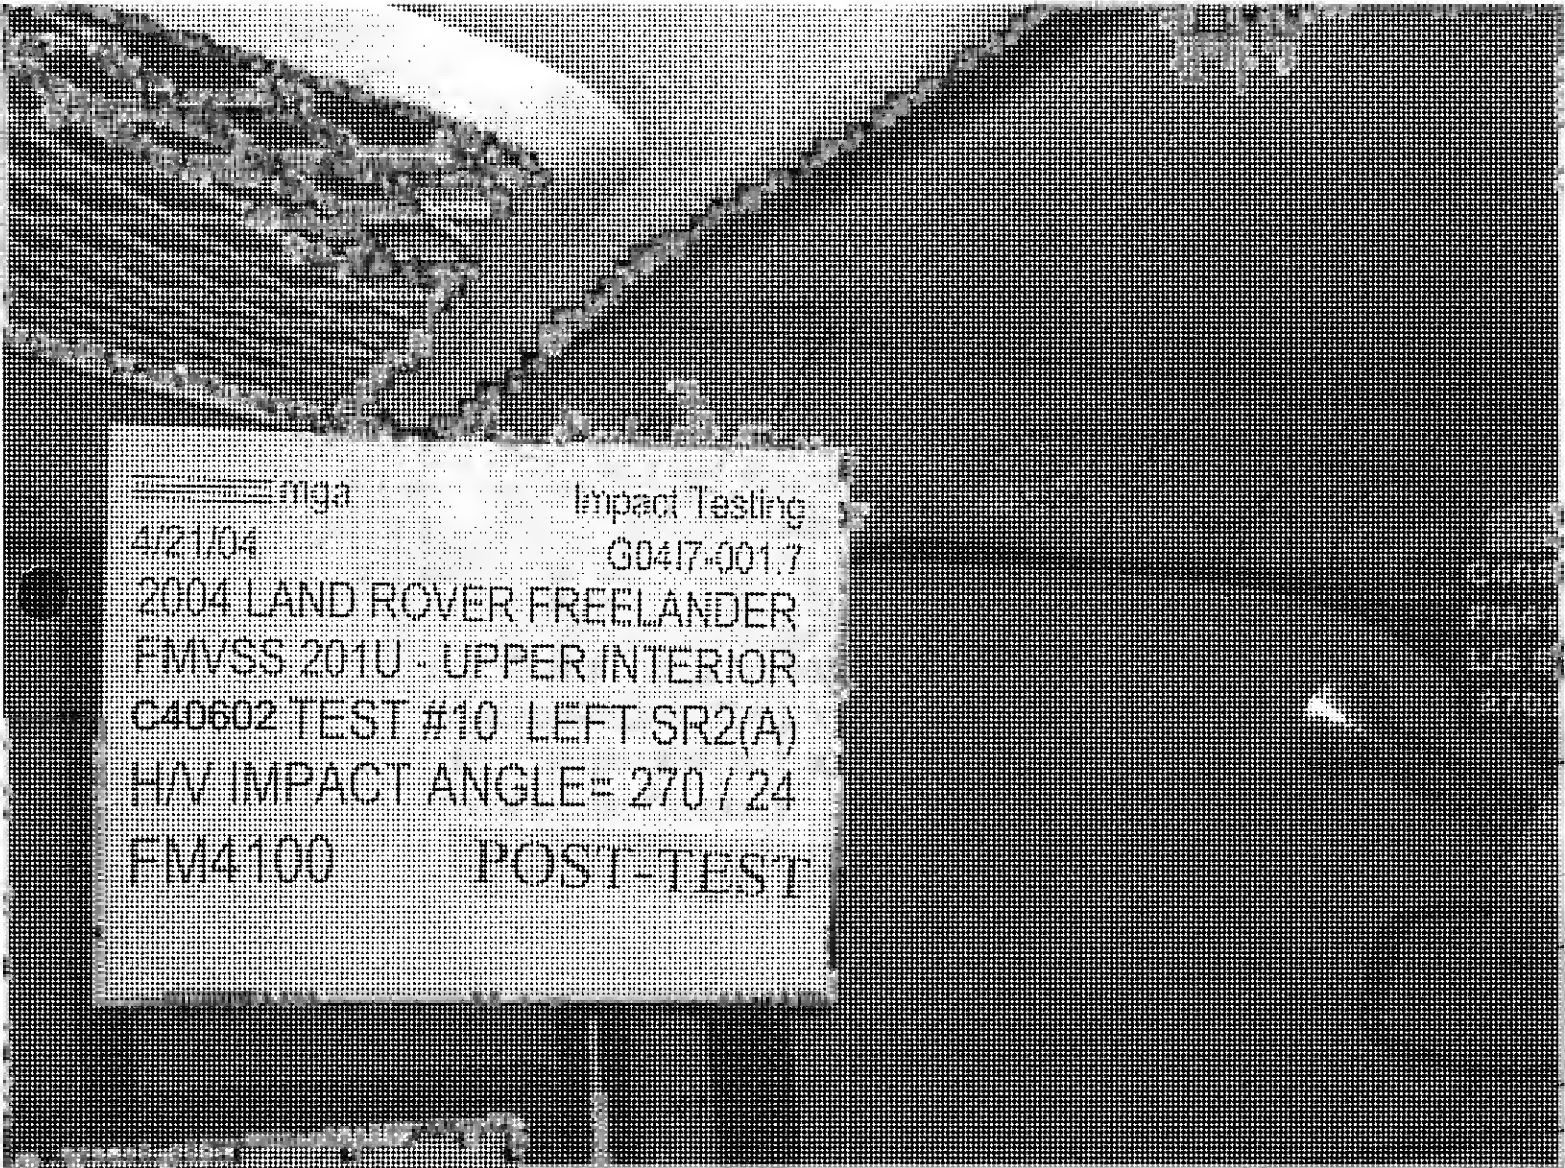
Impact Testing
4/21/04 G0417-001.7
2004 LAND ROVER FREELANDER
FMVSS 201U - UPPER INTERIOR
C40602 TEST #10 LEFT SR2(A)
H/V IMPACT ANGLE= 270 / 24
FM4100 POST-TEST

SR2(A) Left: Slight headliner deformation.

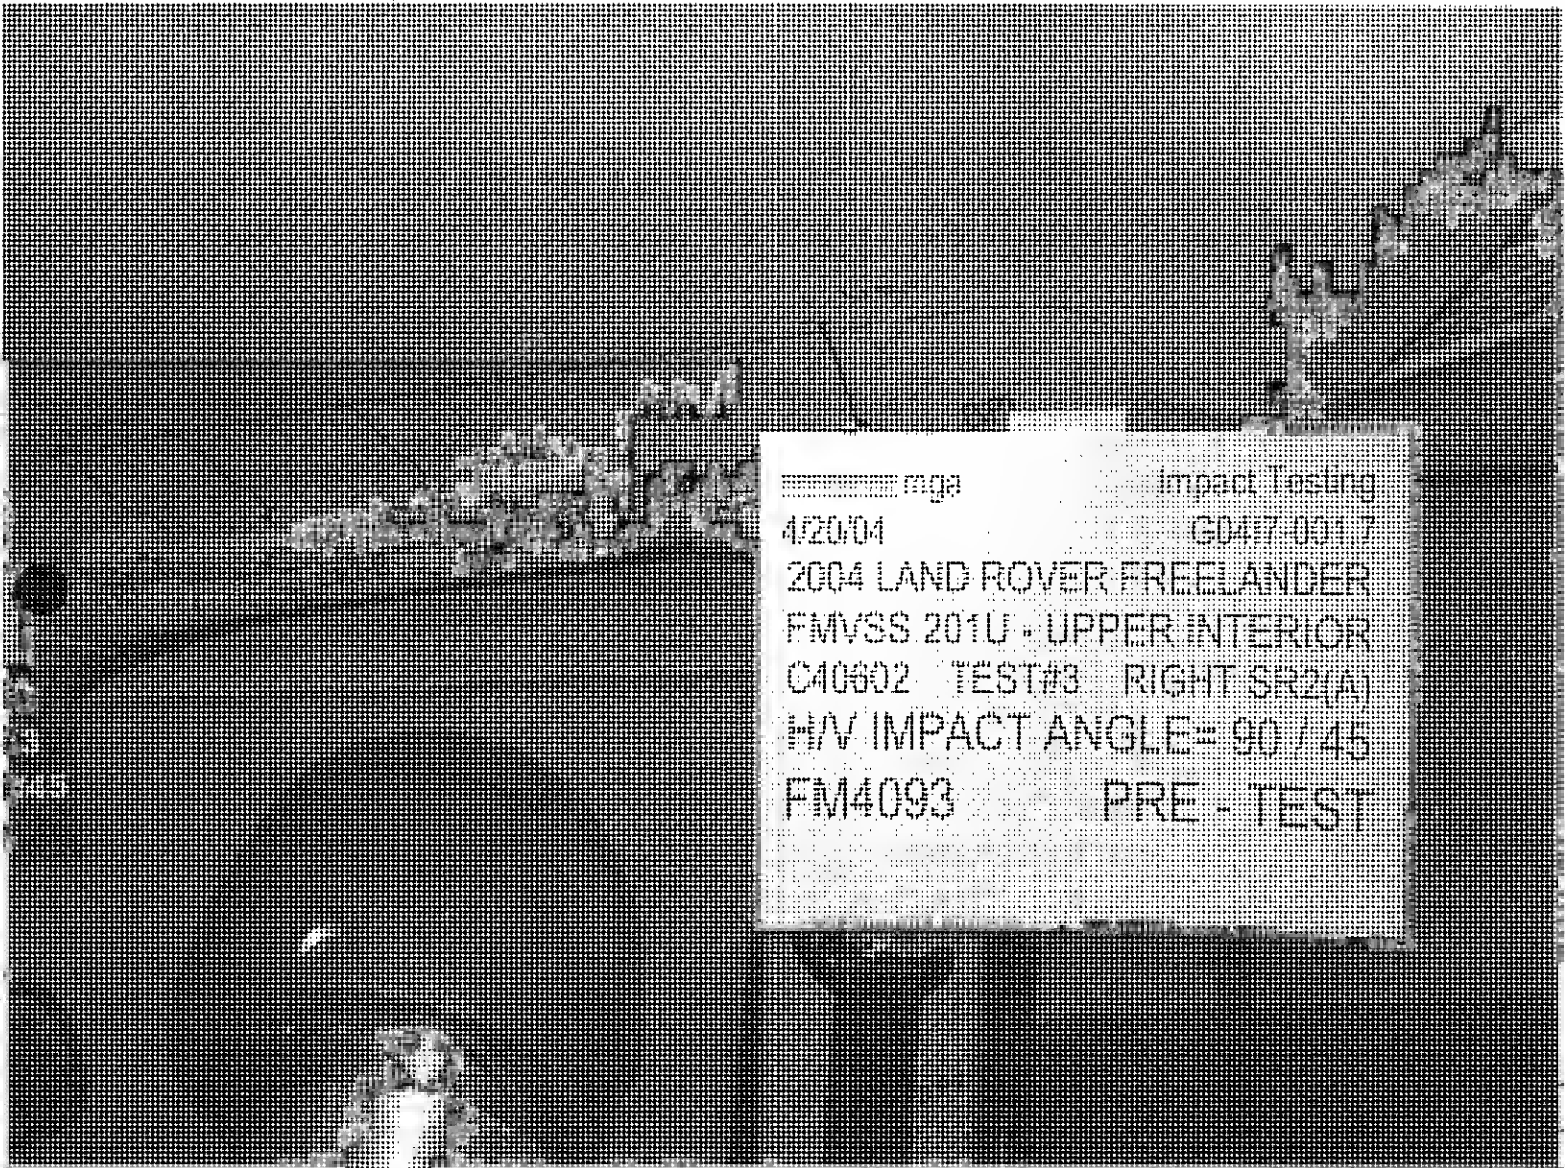
Impact Testing
4/20/04 G0417-00117
2004 LAND ROVER FREELANDER
FMVSS 201U - UPPER INTERIOR
C40602 TEST#3 RIGHT SR2(A)
H/V IMPACT ANGLE= 90 / 45
FM4093 PRE - TEST

SR2(A) Right: The grab handle was compressed into the side rail.
